# RESTORATION OF A DAMAGED SLOPE DUE TO LANDSLIDE FOR THE SAFETY OF A MICROWAVE TOWER

# A. J. Khan<sup>1</sup>, A. Siddique<sup>1</sup> and M. A. Rouf<sup>1</sup>

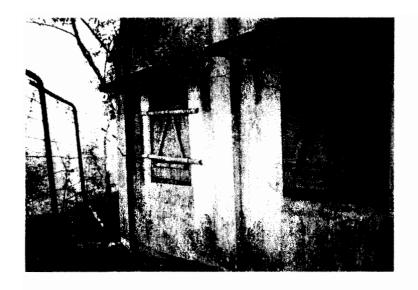
A microwave transmission tower is situated on top of a 15m high hill in Sylhet, a district in the Northeast part of Bangladesh. Since 1973, the tower has been of extreme importance in terms of providing continuous telecommunication support to the Sylhet zone in particular and to the whole country in a greater extent. However, only over the last three years, the mild slopes (mostly 2H:1V) of the geological formation started showing signs of instability. It was observed during the field visit that the slopes on the Southeast, South and Southwest parts of the tower have suffered some damages due to erosion of the topsoil of the slopes. In order to restrict further landslide due to erosion of these slopes, measures were taken in the form of laving boulders on the slopes and driving of timber piles. These preventive measures, although, apparently reduced the risk of potential landslides, some active cracks were observed in the structural members of the equipment room abutting these slopes. The slopes on the Northwest part have also undergone tremendous loss of topsoil due to erosion caused by heavy rainfall during monsoons. The one-storied storeroom, adjacent to the crest of the Northwest slope (Fig. 1), was found abandoned due to the danger of inevitable structural collapse. In the West part of the formation, near the water tank for the premise, the angle of failed slopes was found to be near vertical (Fig. 2).

Fig. 1. Damaged store room on North-west slope

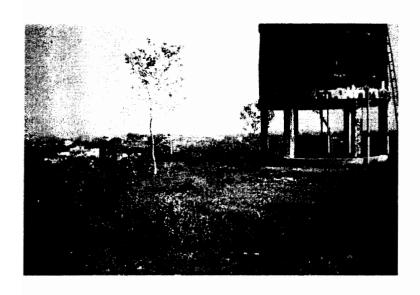
Fig. 2. Near vertical West side slope abutting the water tank

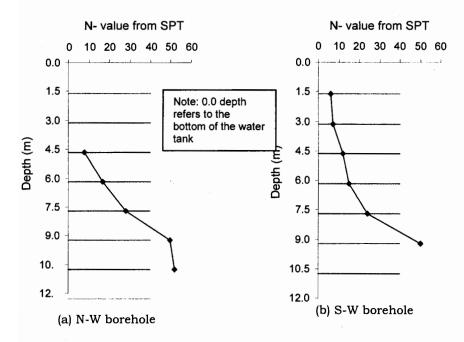
The field investigation at the microwave tower site consisted of drilling six boreholes, recording density/stiffness characteristics of soil layers by carrying out Standard Penetration Tests (SPT) and collecting sufficient numbers of disturbed and undisturbed tube samples. The borelogs of North-West and South-West slopes are shown in Fig. 4. Split-spoon sampler was used to obtain the disturbed samples. Undisturbed samples were retrieved from cohesive layers of the boreholes by pushing conventional 76 mm external diameter thinwalled Shelby tubes following the procedure outlined in ASTM D1587 (ASTM, 1989). All the samples were later transported to the laboratory of Bangladesh University of Engineering and Technology (BUET) for detailed investigation.

Fig. 4. Typical borelogs at the microwave tower site

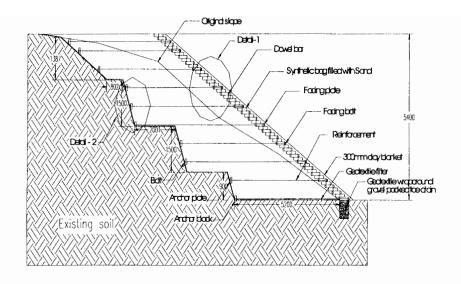
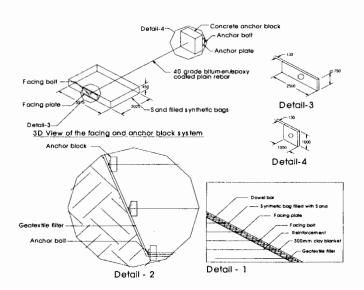
Fig. 6. Details of suggested anchored earth protection system

Detail of the proposed anchored earth system for slope protection, for a typical slope section, is presented in Fig. 6. The external and internal stabilities of the proposed anchored earth slope system have been checked by the method outlined by Lee and Oh (1997), Jones (1996) and BS 8006 (1995).

- (i) Synthetic sand bag facings located at the face of the slopes are used to prevent local loss of soil. The sand material in the bags is used to facilitate uninterrupted flow of water towards the toe drain.
- (ii) Horizontal steel reinforcements running through the sand bags to the required length are intended to withstand the horizontal thrust due to self weight of the backfill, pore water pressure and surcharge at the top surface.
- (iii) The vertical dowel bars inserted through the bundle of every three bags are provided to secure the bags in place during the

- (v) Granular material, intended to facilitate the flow of rain water, is used as backfill compacted in layers up to the full height of the slope.
- (vi) Geotextile wraparound gravel filled drain located at the toe of the slopes are designed to collect and discharge the water flowing through the compacted granular backfill.

- it will retain the soil of the existing slope and ensure uninterrupted water flow due to rainfall.
- (viii) Concrete anchor blocks connected to the rear end of the reinforcements with nut and bolt are intended to mobilise passive resistance at each level of reinforcement to internally stabilise the horizontal thrust so that no force is transferred to the bag facings.
